Serial: RNP-RA/00-0122

H. B. ROBINSON STEAM ELECTRIC PLANT, UNIT NO. 2  
DOCKET NO. 50-261/LICENSE NO. DPR-23

LICENSEE EVENT REPORT NO. 2000-001-00  
MANUAL REACTOR TRIP DUE TO TURBINE  
ELECTRO-HYDRAULIC CONTROL TUBING FAILURE

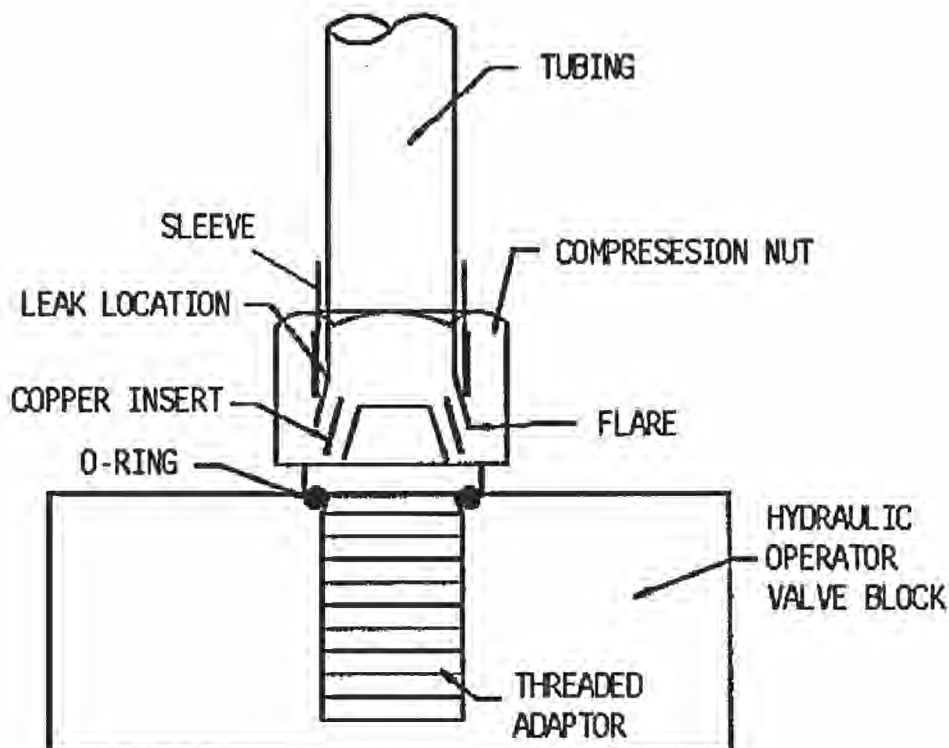
Investigation of the leak revealed a circumferentially oriented crack in the EH fluid tubing [TBG] (extending approximately 2/3 of the tubing circumference) at the EH system supply line connection to the hydraulic actuator for the Moisture Separator Reheater 2A Reheat Intercept Valve [V]. The failed section of tubing [TBG] was repaired prior to restart of the unit. Figure 1 shows a diagram of the tubing connection and the approximate location of the tubing leak. An investigation to determine the cause of the tubing failure was initiated on June 21, 2000. Metallurgical examination of the failure was conducted to assist the investigation. The investigation and metallurgical examination discovered evidence of both corrosion and vibration and that a material defect in the tubing was present at the failure location. The investigation also discovered that two copper inserts had been inadvertently installed in the fitting where only one is expected. The investigation concluded that the extra copper insert did not significantly contribute to this tubing failure.

This event was caused by a failure of the Main Turbine System [TA] EH System tubing [TBG]. An investigation of the cause of the tubing [TBG] failure concluded that the failure was caused by corrosion fatigue initiated at a defect on the outer diameter surface of the tube. There were no operator errors or procedural deficiencies that contributed to the event.

FIGURE 1: PARKER-HANNIFIN  
TRIPLE-LOK 37° FLARED TUBE FITTING  
WITH COPPER INSERT

The broken EH system fluid line was repaired and the other two lines on this valve were disconnected and inspected, including a liquid penetrant test. The EH system fluid supply lines for the other three intercept valves were also disconnected and inspected, including a liquid-penetrant test. There were no additional problems found. An engineering walk-down of the EH system was performed. The tubing support for the tubing that failed was modified to reduce vibration.

Improved fittings will be installed on the 14 Main Steam System [SB] and Main Turbine System [TA] valves operated using the EH system. Flexible tubing will be installed in appropriate portions of the EH system, as determined by an engineering evaluation, to reduce the fatigue stresses on EH system tubing. These actions will be completed prior to the end of the next refueling outage (Refueling Outage 20, currently scheduled for the spring of 2001).
